Project Progress Report

CLIENT: AEA/City of Akutan			PROJECT: Akutan Electrical Distribution Upgrade		DATE: September 15, 2010
PROJECT NO.: AEA-09-022 RQ3127			REPORT NO.: 2	REPORT PERIOD: 7/21/2010 through 8/31/2010	
DATE	PRIMARY TASK	AREA	PROGRESS		
7/21	Restaging	NA	Moved newly received materials to powerhouse staging area; completed boardwalk replacement around Xfmr 5; performed equipment maintenance; discussed potential changes w/AEA engineer.		
7/22	Trenching	B	Digging by equipment & hand from JBox B to area of Xfmr 8; primary cable and HDPE installed for 3-phase heading toward JBox C, single-phase to Xfmr 8 & single-phase intended for Xfmr 9; installed ditching tape and backfilled same area; ran single-phase primary cable from JBox B to Xfmr 6 (by streetlight 7-L3), and streetlight wire and ¾" HDPE from Xfmr 6 to streetlight 7-L3.		
7/23	Trenching	B	Completed digging & installing 3-phase primary cable & HDPE to JBox C; installed ditching tape, backfilled & seeded West side of VPSO Bldg; hand dug & installed single-phase line from Xfmr 9 to Xfmr 10 .

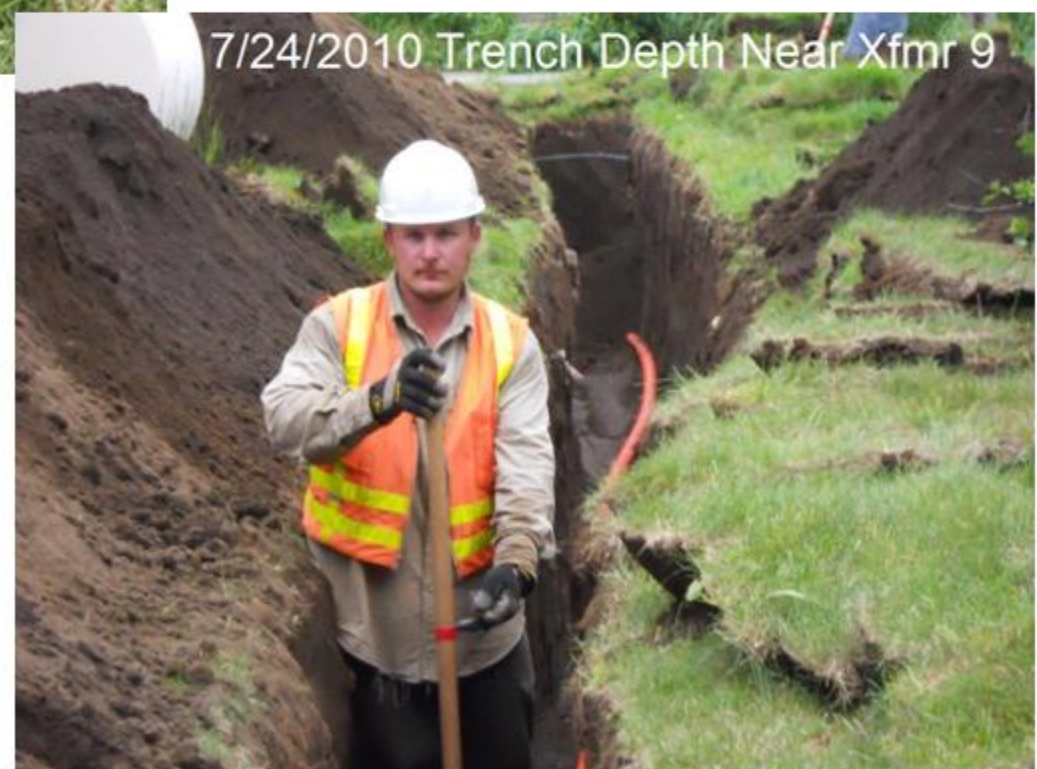
7/24/2010 Trench Depth Near Xfmr 9

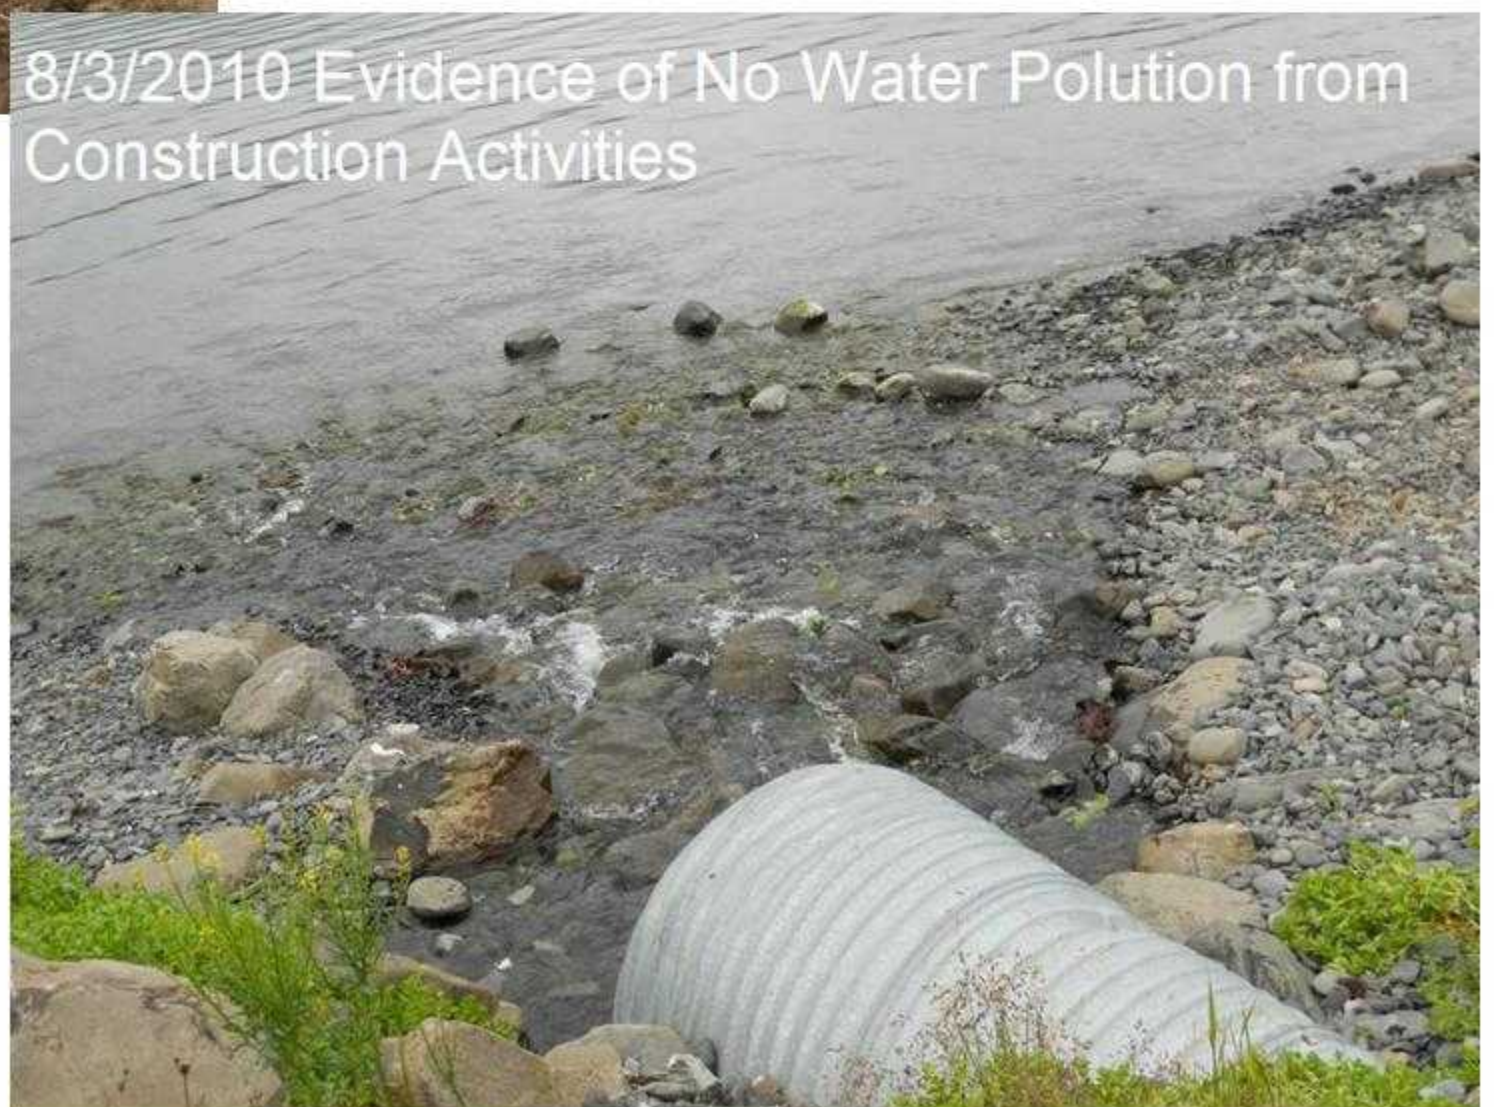
8/3/2010 Evidence of No Water Polution from
Construction Activities

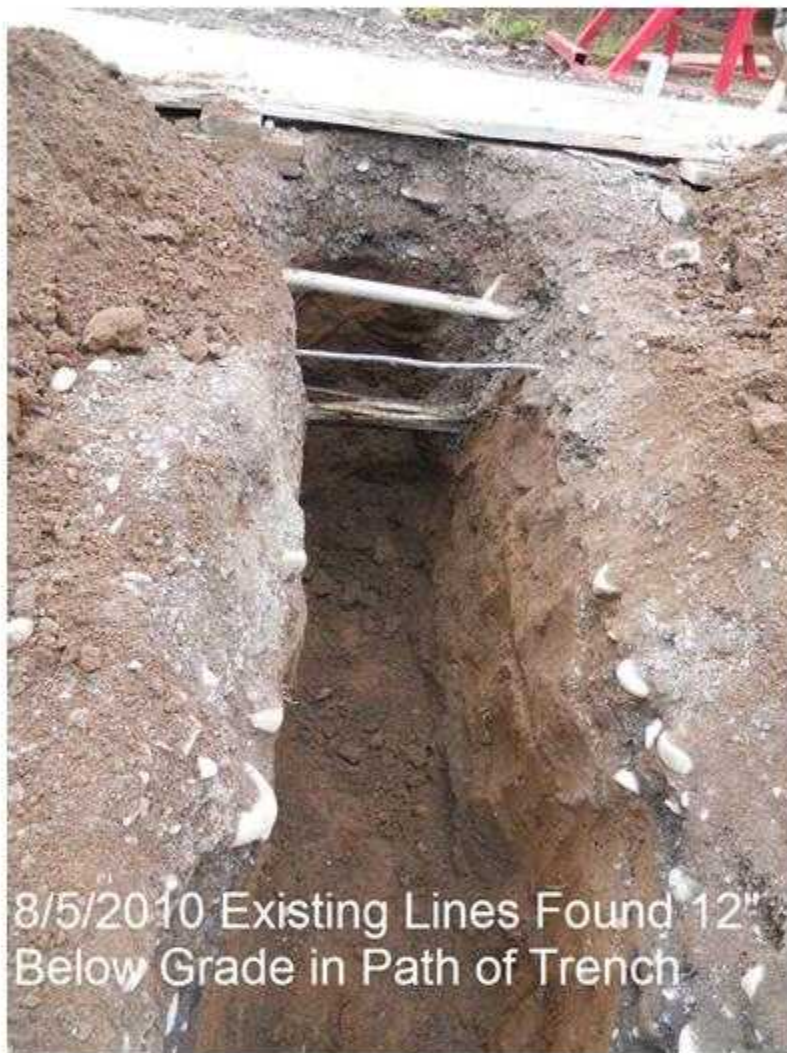
8/5/2010 Existing Lines Found 12"
Below Grade in Path of Trench

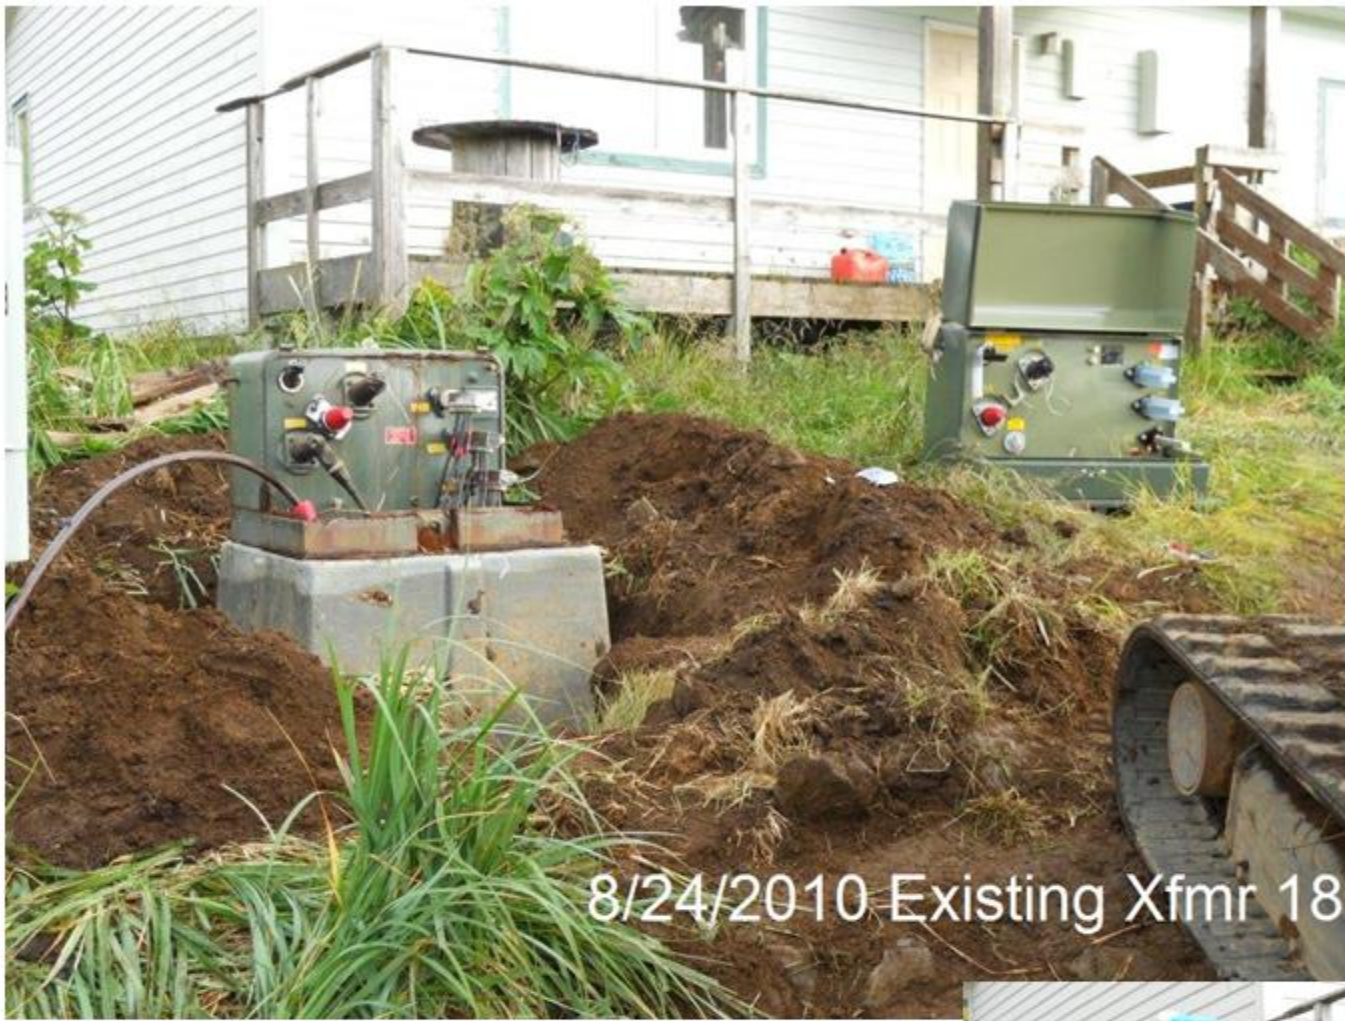
8/24/2010 Existing Xfmr 18

8/25/2010 New Xfmr 18 & Vault
